UC Santa Cruz
Campus
Bike Parking
Project

Introduction

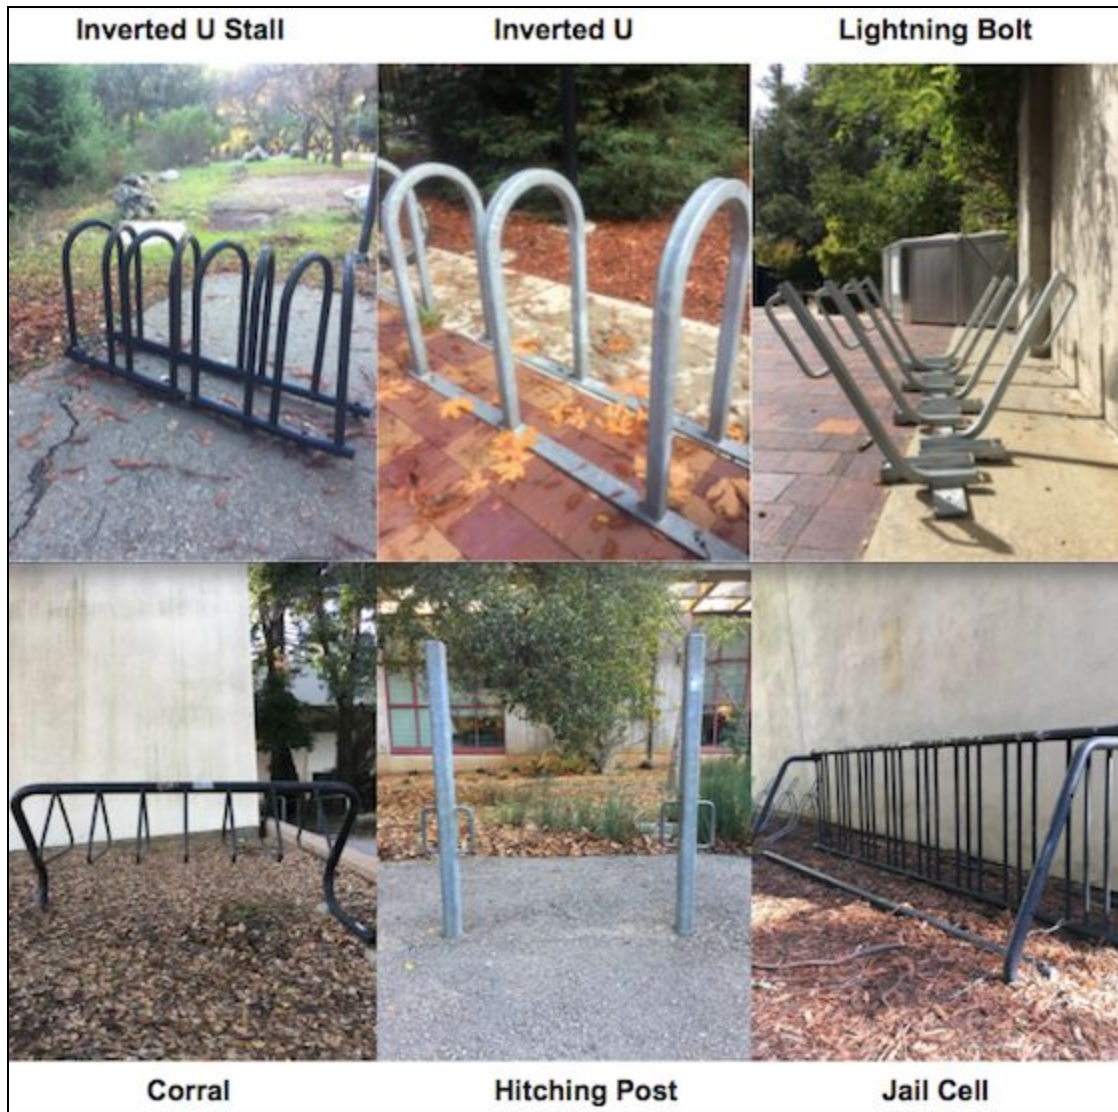
well. We recorded the total capacity of the racks, how full they were, their condition and whether they were convenient to access. In order to be thorough, we travelled the campus by foot and by car in search for all bike racks near academic buildings. Shown below are the different types of racks found throughout the campus:

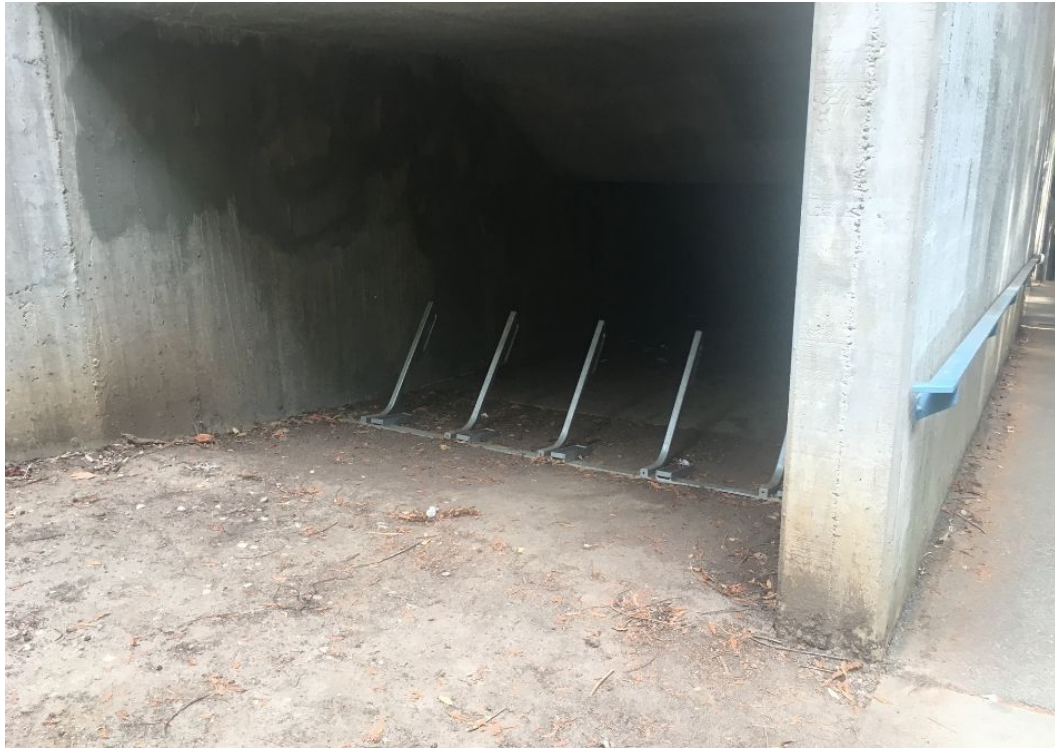
Figure 8: Example of Poor Location (Classroom Units)

There were 6 racks in poor locations; places that were hidden or close to the road. **Figure 8** shows lightning-bolt racks under the staircase of Classroom Unit 2 which are completely hidden, making it both dangerous and not easily accessible for someone to park their bike. Areas with less foot traffic,

especially those that are hidden or in dimly lit areas, are more vulnerable to theft. There were 10 racks that were classified as having poor design because of their placement near other racks and lack of proximity to pathways. **Figure 9** shows an example near Vivas (Merrill) where a jail cell rack and lightning bolt rack are too close to each other. Two bikes were taking up two spots on each rack because of their adjacent positioning. The lightning bolts are also placed on a ledge, making it difficult to use the rack altogether. Another example of poor design can be seen in **Figure 10**, where two bike corrals by Kerr Hall are blocked by the handrail. In order to lock a bike to it, someone would have to lift their bike over the rail which is a hassle and inconvenient. About 22 racks were either rusty,

<p>14. Classroom Units</p>	<p>Rack is hidden, not in a well lit area, and not in full view of sidewalks/paths</p>	 	<p>Relocate to a more suitable location</p>  
<p>15. Base of Campus (By sign)</p>	<p>Racks are hidden beneath trees and to the side of the bus stop</p>	 	<p>Relocate to a more suitable location:</p>  
<p>16. Kerr</p>	<p>Racks are hidden under trees and near dumpsters</p>

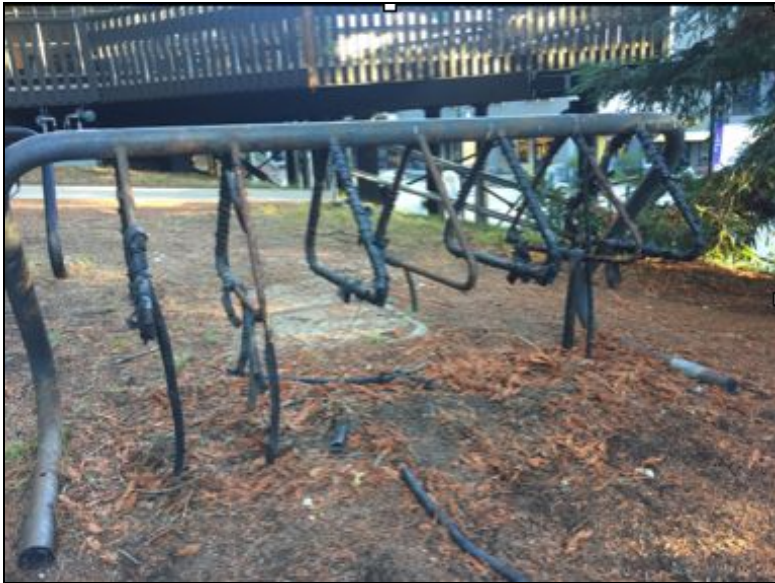
Figure 11: Example of a Rusty/Tattered Rack

cracked, tattered, or bent which classified them in poor condition (**Fig. 11**). Only a fraction of the racks in poor condition are displayed on the map because some locations had more than one problem; if a location has multiple issues, the most pressing and crucial issue was presented on the map. The inverted-U stalls were the only ones that appeared to be “cracked,” meaning that the rack itself was not cracked but the padding around it was (**Fig.12**). Aside from this aspect, poor condition was not related to a specific rack type. Though they were not aesthetically pleasing, it is unsure whether their condition compromises their safety and the safety of the bikes locked to them. Altogether, there are a range of bicycle parking improvements that need to be made to the UCSC campus in order to encourage cycling as a convenient and safe mode of transportation.

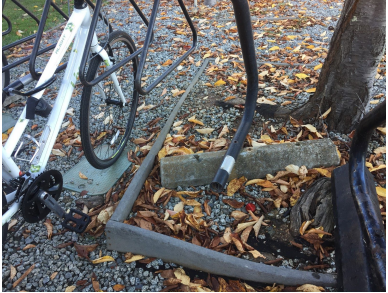
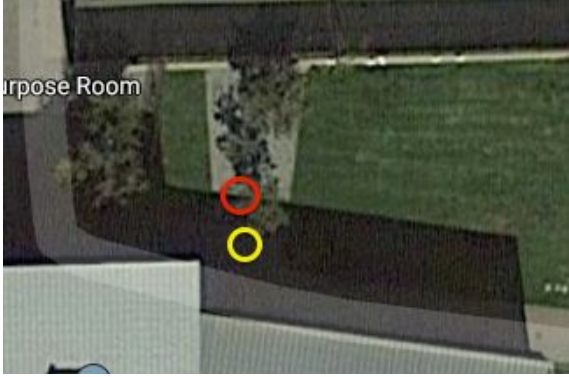
Location	Problem	Image	Proposed Action
1. Opers	Bike corral is on uneven ground, individuals must lift bike to park

Relocate to a more suitable location:

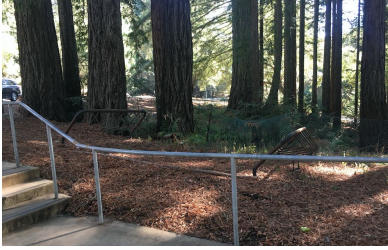
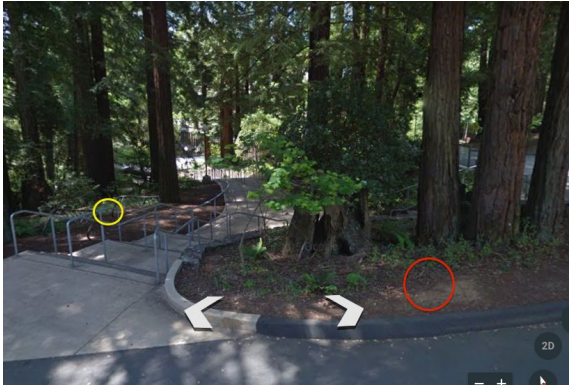
2. Kerr Hall	Bike parking is not located along a path, individuals must lift bike over a rail or a stoop in order to park

Relocate to a more suitable location:

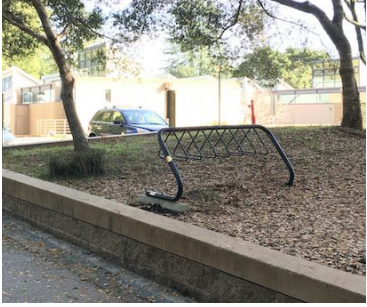
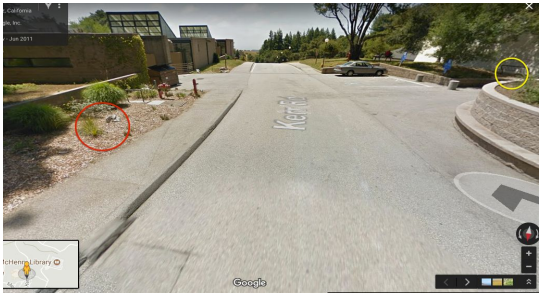
3. Media Theatre	Bike parking is elevated off the ground on ledges, individuals must lift bikes over a large ledge in order to park

Relocate to a more suitable location:

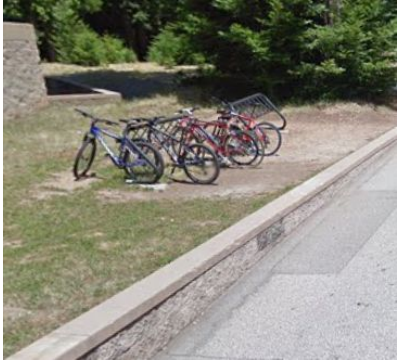
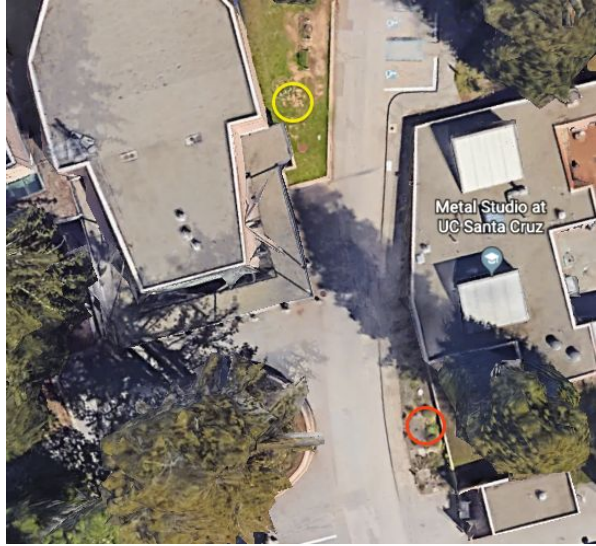
<p>4. Media Theater Near Classroom</p>	<p>Bike parking is elevated off the ground on ledges, individuals must lift bikes over a large ledge in order to park</p>

<p>Relocate to a more suitable location:</p>

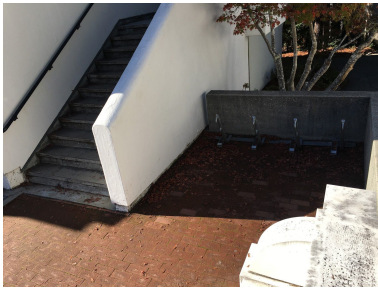
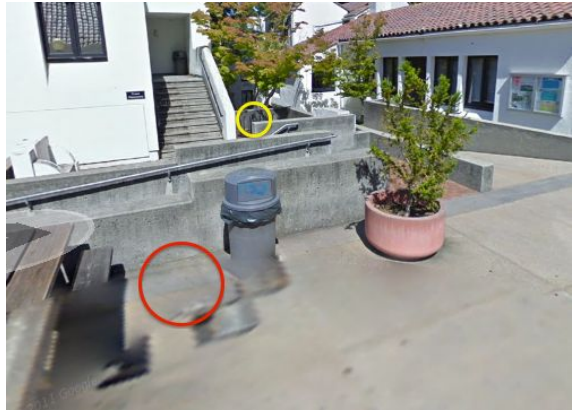
<p>Metal Studio at UC Santa Cruz</p>
<p>5. Crown Classrooms</p>	<p>Bike parking is not located along a path, individuals must carry their bikes down a set of stairs in order to park</p>

<p>Relocate to a more suitable location:</p>

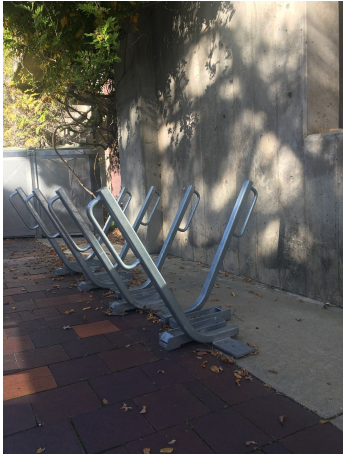
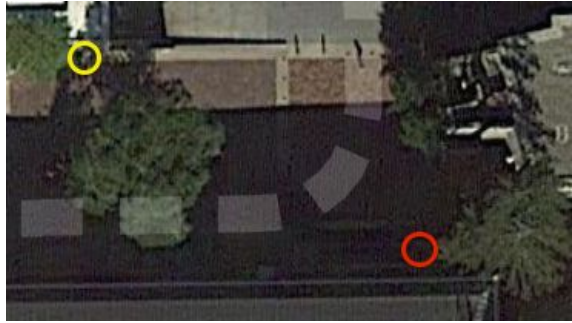
<p>6. ISB</p>	<p>Racks are placed too close to wall for optimum usage</p>

<p>Relocate to a more suitable location:</p>

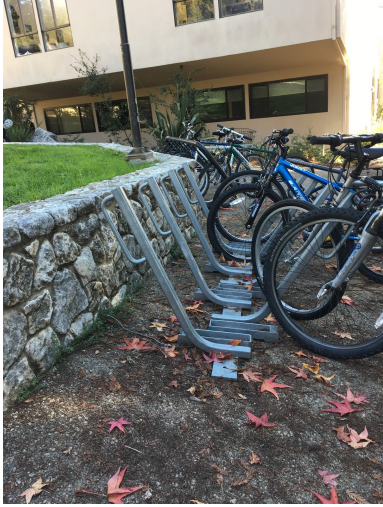
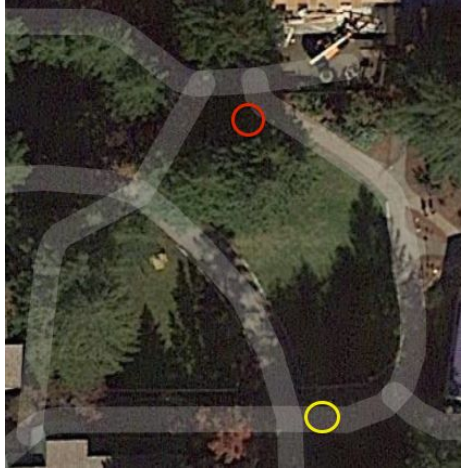
<p>7. Merrill Classrooms</p>	<p>Racks are placed too close to wall for optimum usage</p>

<p>Relocate to a more suitable location:</p>

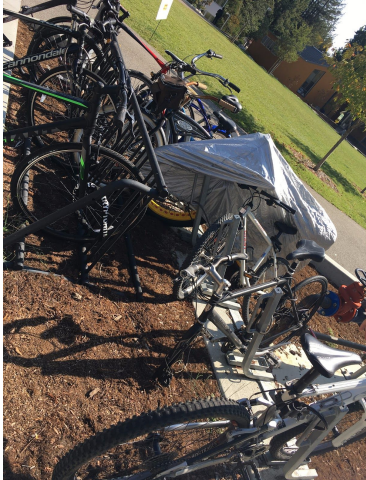
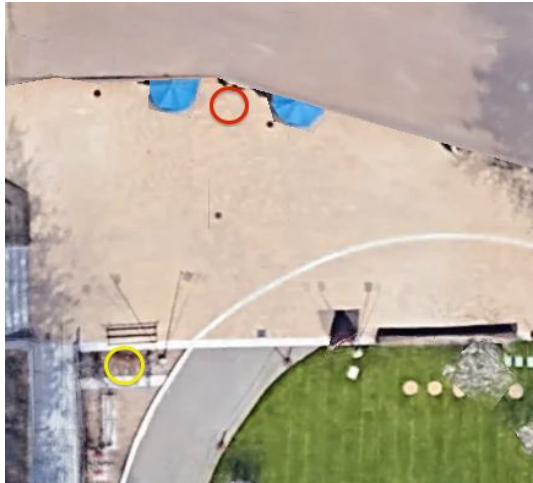
<p>8. Merrill (By Vivas)</p>	<p>Racks are placed too close to one another for optimum usage</p>

<p>Relocate to a more suitable area:</p>

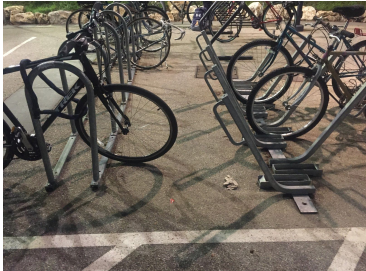
<p>9. Baytree Bookstore</p>	<p>Racks are placed too close to one another for optimum usage</p>

<p>Increase space between current racks.</p>

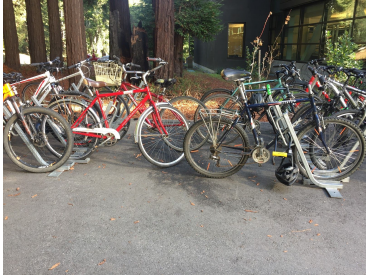
<p>10. Science Hill (Top)</p>	<p>Racks are located too close to one another for optimum usage</p>

<p>Increase space between current racks.</p>
<p>11. Area outside of the Bike Co-op</p>	<p>Very tattered, rusty</p>

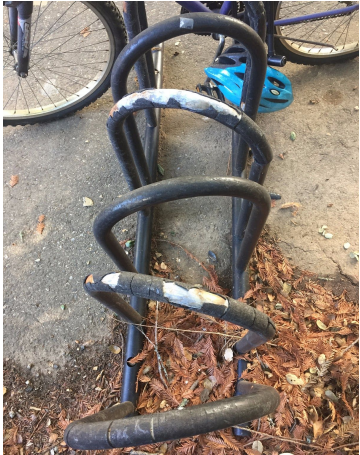
<p>Replace with either lightning bolt or inverted-U style.</p>
<p>12. Bottom of Earth and Marine</p>	<p>Very tattered</p>

<p>Replace with either lightning bolt or inverted-U style.</p>
<p>13. ARC Center</p>	<p>Hidden under trees, located in a low trafficked area</p>

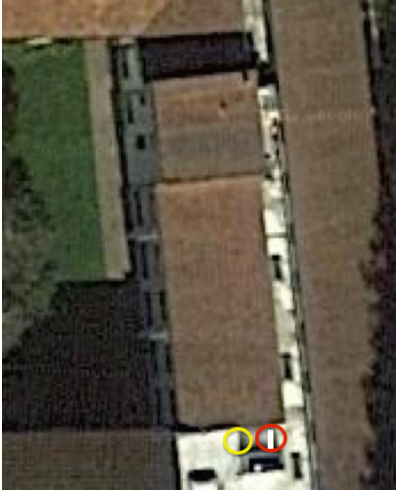
Location	Fullness	Reasoning for Additional Parking	Proposed Area For Additional Parking
1. Stevenson (Near classrooms)	125% Full (5/4)	High Percentage of Fullness	Add adjacent to current bicycle parking:

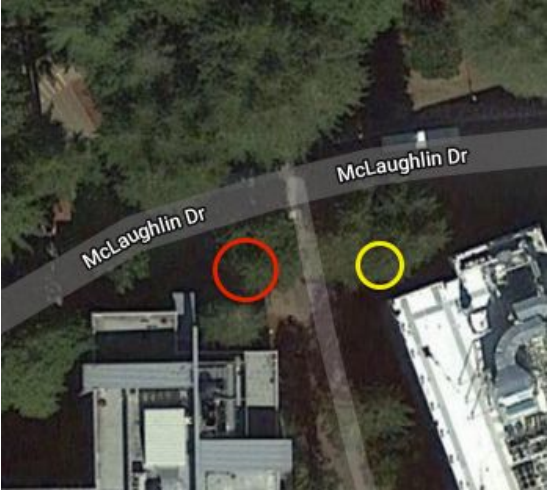
2. Top of Science Hill	118.75% Full (19/16)	High Percentage of Fullness

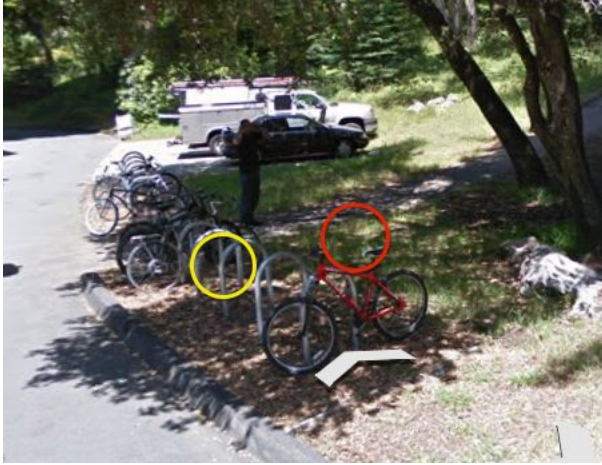
3. McHenry (Front)	94.74% Full (36/38)	High Percentage of Fullness	Add an additional row of inverted-U racks behind current inverted-U racks:

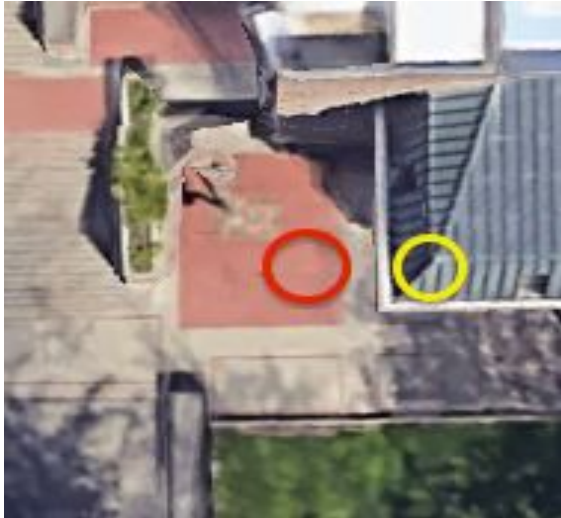
<p>4. Science Hill (Bottom of Nat. Sci.)</p>	<p>80% Full (4/5)</p>	<p>High Percentage of Fullness</p>

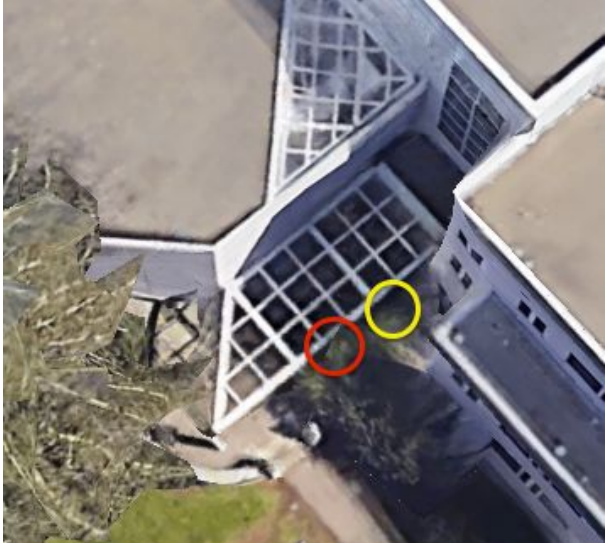
<p>5. Science Hill (Earth and Marine- near cafe entrance)</p>	<p>75% Full (3/4)</p>	<p>High Percentage of Fullness</p>	<p>Add adjacent to current bicycle parking:</p>

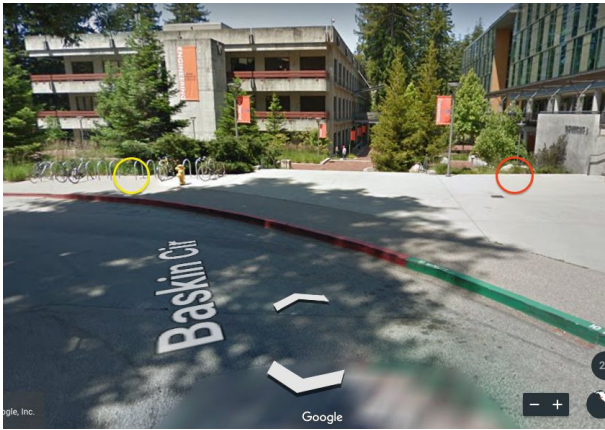
6. Engineering Near Road	75% Full (9/12)	High Percentage of Fullness

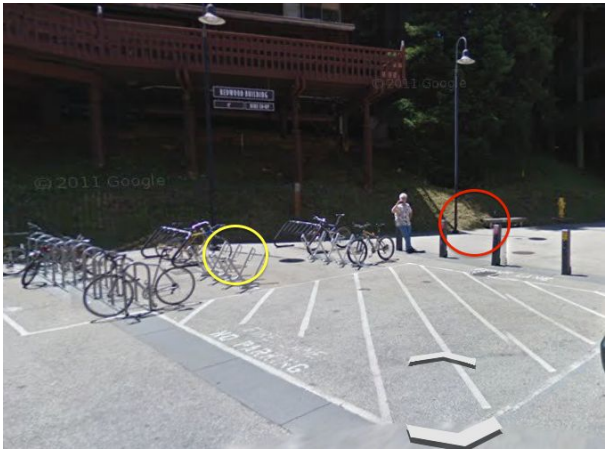
7. Baytree Bookstore	70.27% Full (26/37)	High Percentage of Fullness	Add adjacent to current bicycle parking:

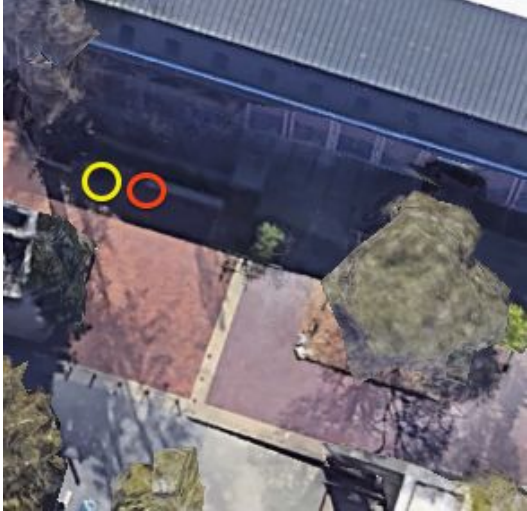
8. Science Hill (Back of ISB)	80% Full (12/15)	High Percentage of Fullness	Add adjacent to current bicycle parking:

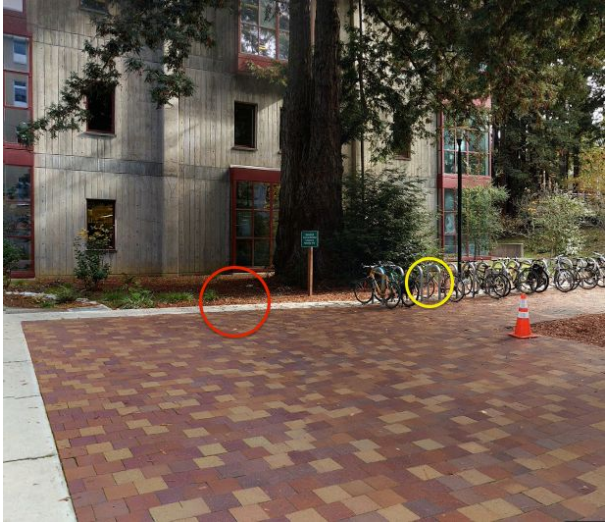
<p>9. S&E Plaza</p>	<p>72% Full (18/25)</p>	<p>High Percentage of Fullness</p>	<p>Add adjacent to current bicycle parking:</p>

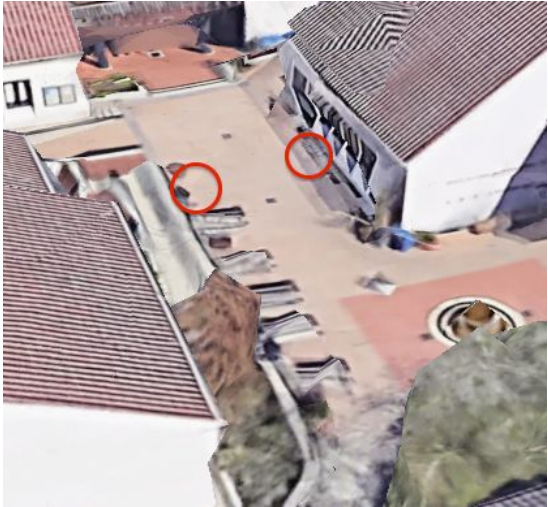
<p>10. Crown Classrooms (Outside of Banana Joes)</p>	<p>N/A</p>	<p>Area noticeably lacking enough bike parking</p>
